## Abstract

Adding sand fences to a dune can significantly impact morphology, ecology, and human interactions with the landscape. Although the effects (intended and unintended) of sand fences have been documented on ocean coasts, no such study has focused on the Great Lakes region. In autumn 2015, we visited four Ottawa County Parks along Lake Michigan's coast to map the locations of fences and unmanaged trails. We photographed each site to capture fence settings and conditions. We estimated porosity and recorded damage intensity and type for each fence. We categorized the amount of deposition near each fence using a ranking system. Our results show that fence locations affect human accessibility and sand deposition. Unmanaged trails often appeared to be a byproduct of fence placement. The greatest deposition on average was observed at the least vegetated site closest to the shore. The greatest variation in deposition was observed at a vegetated site on the windward slope of a parabolic dune. Most fences were damaged, lowering their ability to deter human traffic or trap sand. Our study results add to the body of knowledge on sand fence location, orientation, and condition, provid

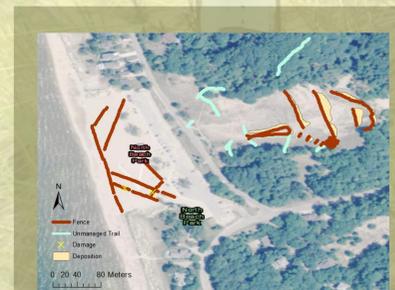
Figure 2- Fences and unmanaged trails at three sites

We mapped 32 fences in total (Figure 2). Unmanaged trails were often observed going around the edge of a row of fences or traveling along the length of a fence. Some unmanaged trails went through damage in fences.

North Beach Dune

Kirk Park

Mt. Pisgah

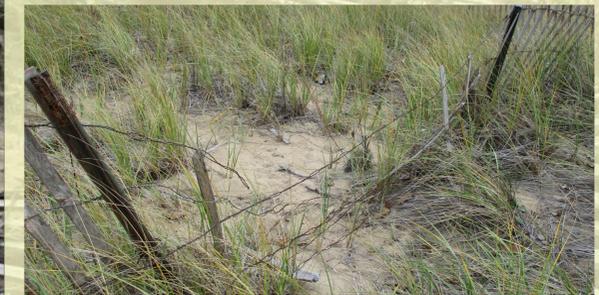
The location of unmanaged trails relative to fences suggests the fences may restrict access to certain areas, but not always to the dune as a whole (Fig 5).

Figure 5- A damaged fence at Mt. Pisgah. Bare sand indicates an unmanaged trail going through the fence.

Most of the sand fences we studied were oriented parallel to the shore and likely intended to slow sand. The fences seemed to have mixed effectiveness in controlling traffic. Our observation of fence damage suggests better maintenance could lead to more erosion prevention.
