# Considering Management for a Blowout in Kitchel-Lindquist-Hartger Dunes Preserve

## Abstract

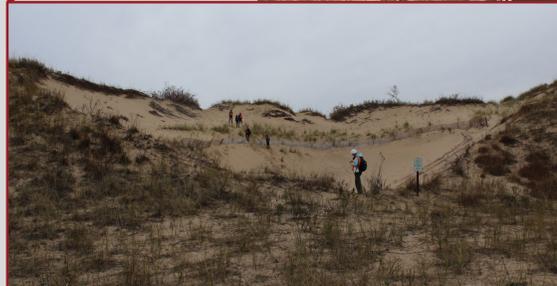
Figure 2: The blowout is shown in the context of nearby infrastructure (blowout circled on aerial view) and as viewed from the west (ground view).

Kitchel-Lindquist-Hartger Dunes Preserve is located in Grand Haven, MI (Fig. 1) near the mouth of the Grand River. The southern blowout (Fig. 2) was the focus of this study and is located next to the preserve parking lot, an outdoor classroom and the North Shore Marina.
