First-Year Research in Earth Sciences: Dunes

Efficacy of Sand Fences in Stabilizing a Steep Active Dune Blowout, Castle Park Reserve, Michigan

**FYRES: Dunes Research Report #4
May 2013**

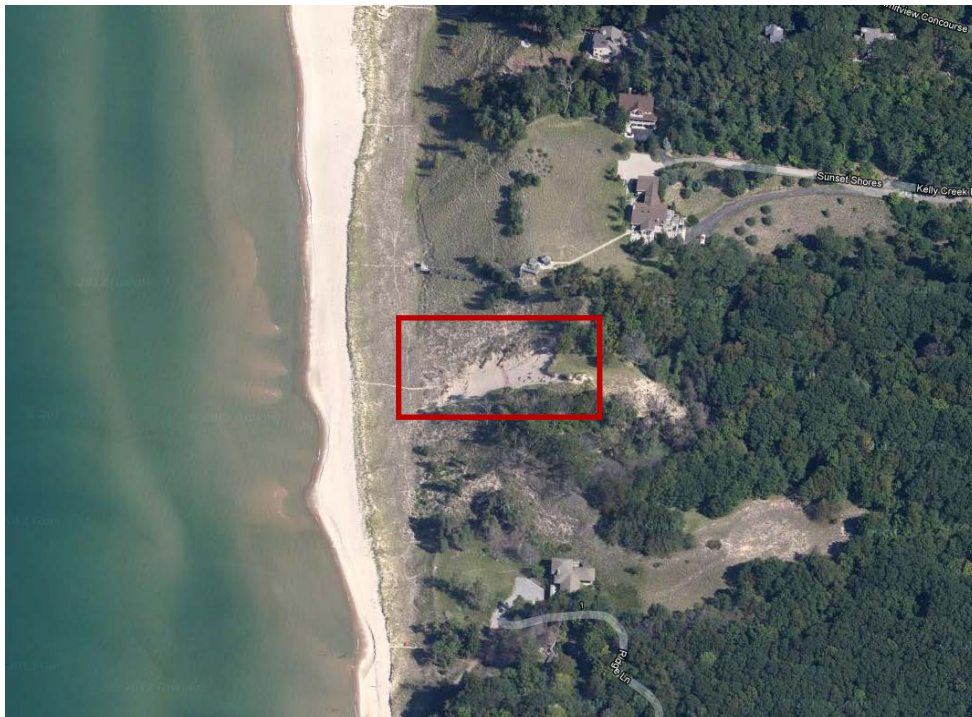
Figure 2: Aerial view of Castle Park Dune, displaying surrounding development (dune blowout highlighted). Source: Google Maps imagery ©2013.

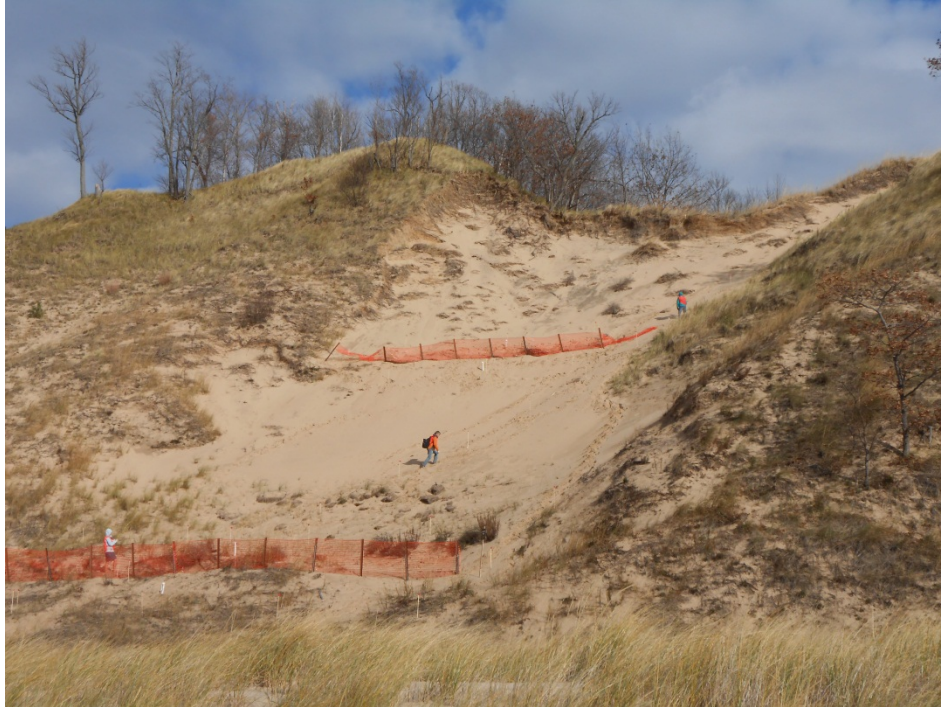
Figure 3: View of windward slope of Castle Park Dune showing the 50-meter high blowout and the two sand fences installed in April 2012. Photo taken November 2012.

The major feature of Castle Park Reserve is a 50-meter high active dune blowout (Figure 3). The blowout is asymmetrical and irregular in shape, approximately 30 meters wide by 70 meters long with a primary dune axis in an east-southeast direction (Figure 4). The dune is steep,

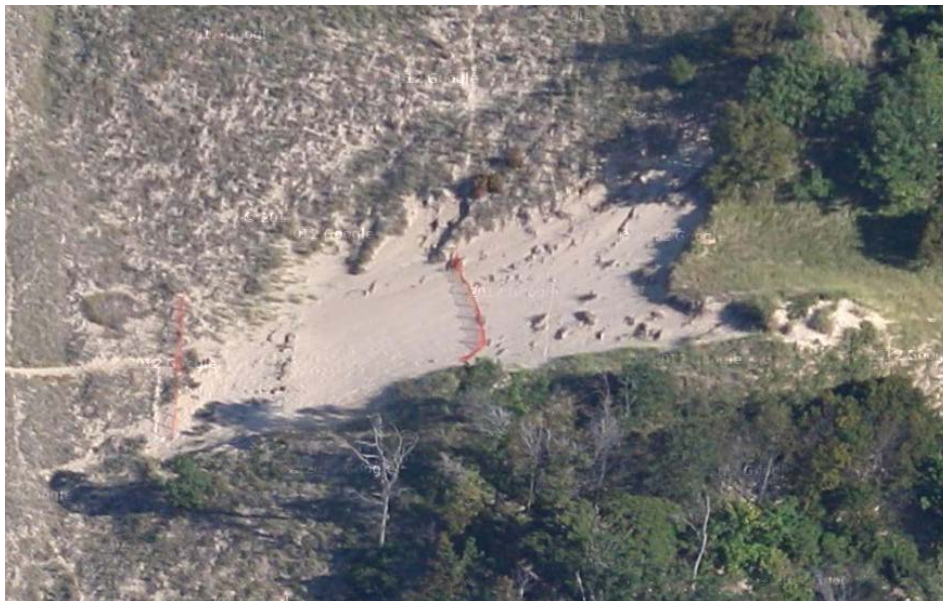
Figure 4: Aerial view of the Castle Park Dune blowout showing the irregular profile of the active face. Source: Google Maps imagery ©2013.

with surface slope angles ranging from 21° to 30° and no vegetation present in the active blowout area. The Land Conservancy suspects that the blowout originated from human disturbance on the dune (Manion 2010).

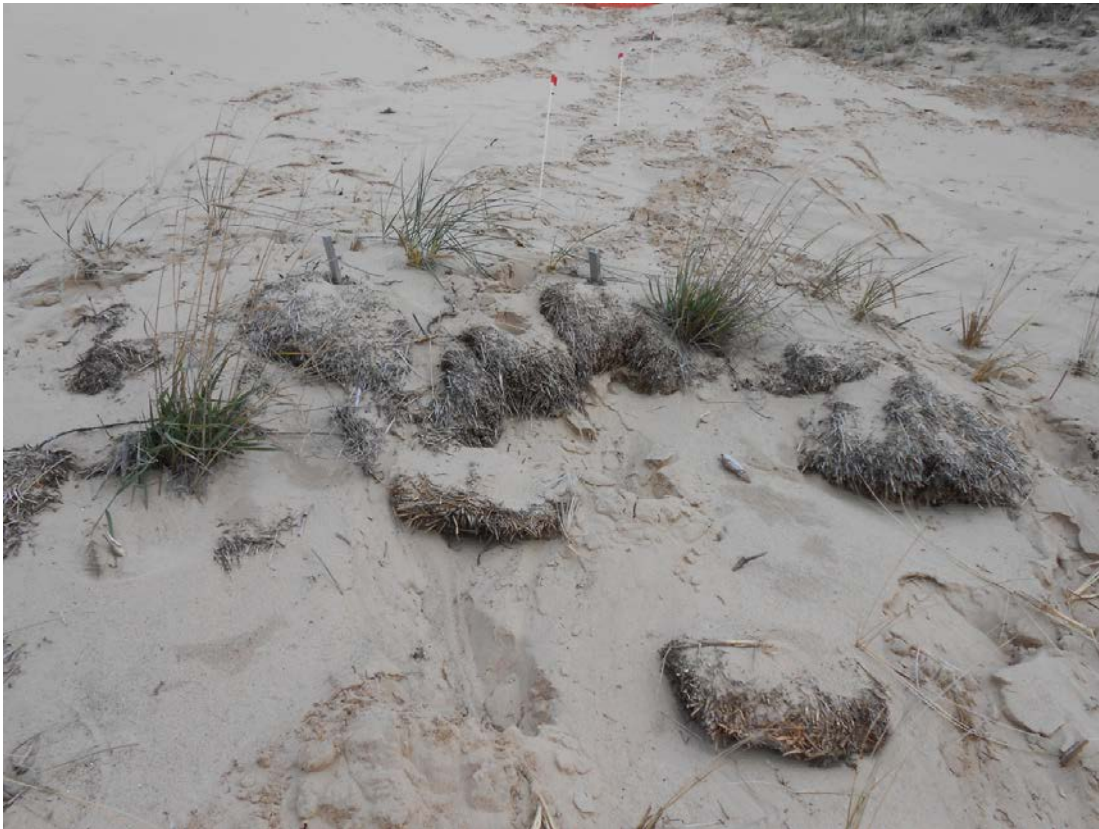
Figure 5: Straw bales placed on the dune in 2009 for surface stabilization remain present in 2012. Photo taken November 2012.

Since acquisition of the property in 2003, the Land Conservancy has been implementing management techniques to stabilize the dune surface. In 2009, straw bales and discarded Christmas trees were placed on the blowout surface in order to trap sand; these items presently remain on the dune surface (Figure 5). In April 2012, two sand fences made of plastic netting were installed on the dune; one fence was placed at the base of the blowout and the other fence was placed two-thirds of the way up the blowout (see Figure 3). Beach grass was also planted leeward of the lower fence in April 2012, but it had not yet firmly rooted by the time of this study in October-November 2012. In the fall of 2011, the Land Conservancy commissioned a study investigating the relationship between sand erosion and invasive species at Castle Park Reserve (Whalley *et al.* 2012). This study classified the dune as active (Whalley *et al.* 2012).

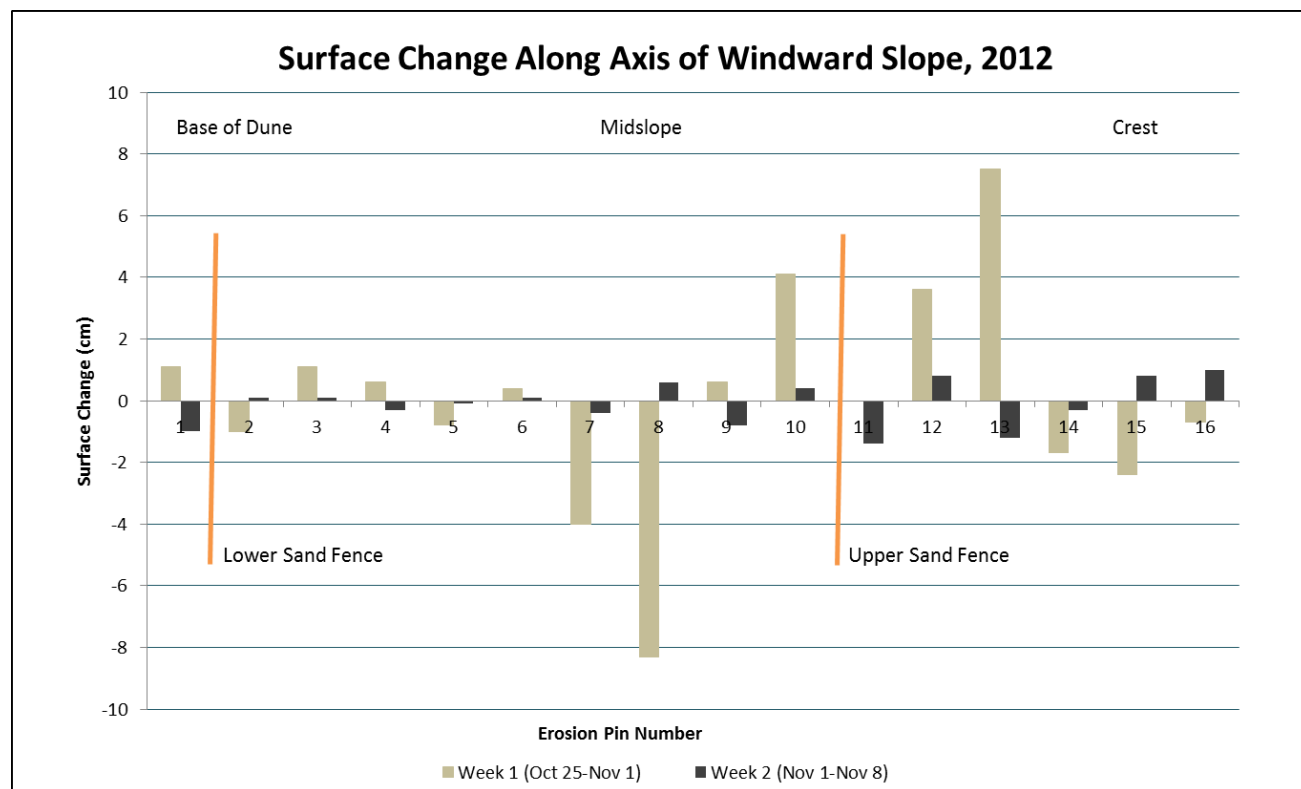
Figure 7: Weekly change in surface level at each erosion pin on the windward slope, October 25 to November 8, 2012.

Measurements from erosion pins along the axis of the dune reveal patterns of sand movement on the blowout face, confirming that the dune is still active. Individual erosion pins experienced erosion and/or deposition depending on the week of the study and location of the erosion pin (Figure 7). In general, weekly changes in sand level were small, averaging 2.3cm/week (absolute value of change), although a weekly surface change as large as 8.3cm erosion at a midslope location was observed. There is a trend of greater erosion and deposition

activity toward the midslope of the dune. For the lower sand fence, there was no noticeable increased sand accretion immediately downwind of the sand fence; weekly absolute values of surface change directly behind this fence (0.95 cm/week) were comparable to surface changes in front of the fence (0.6 cm/week) and further behind the fence (0.73 cm/week). Conversely, there was a small but noticeable difference in surface change near the upper sand fence; weekly absolute values of surface change directly downwind of this fence (0.7 cm/week) were much lower than surface changes upwind of the fence (4.2 cm/week) and further downwind of the fence (3.7 cm/week).

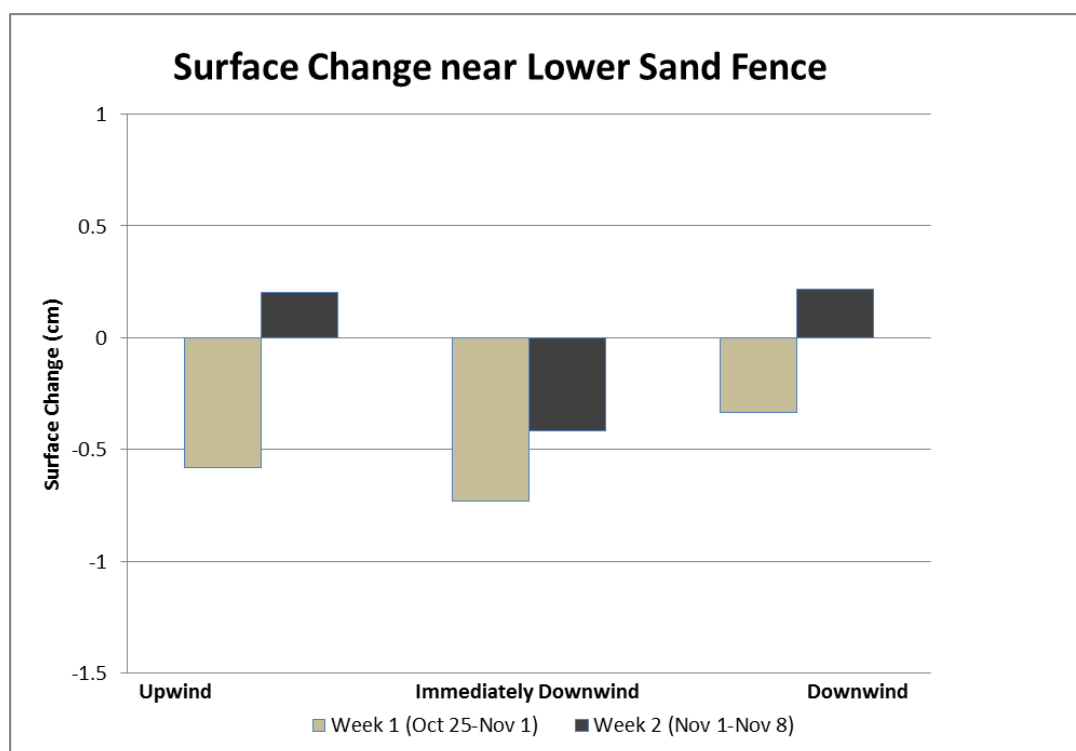
Figure 8: Weekly change in surface level for rows of erosion pins near the lower fence.

The grids of erosion pins around the sand fences showed variable results for both upper and lower sand fences (Figures 8 and 9). Week 1 showed all rows of erosion pins experienced net erosion, but the ensuing Week 2 reversed this trend with 4 of 5 rows of erosion pins experiencing net deposition. The absolute value of weekly surface change was lower at the lower fence (0.41 cm) than at the upper fence (0.83 cm).

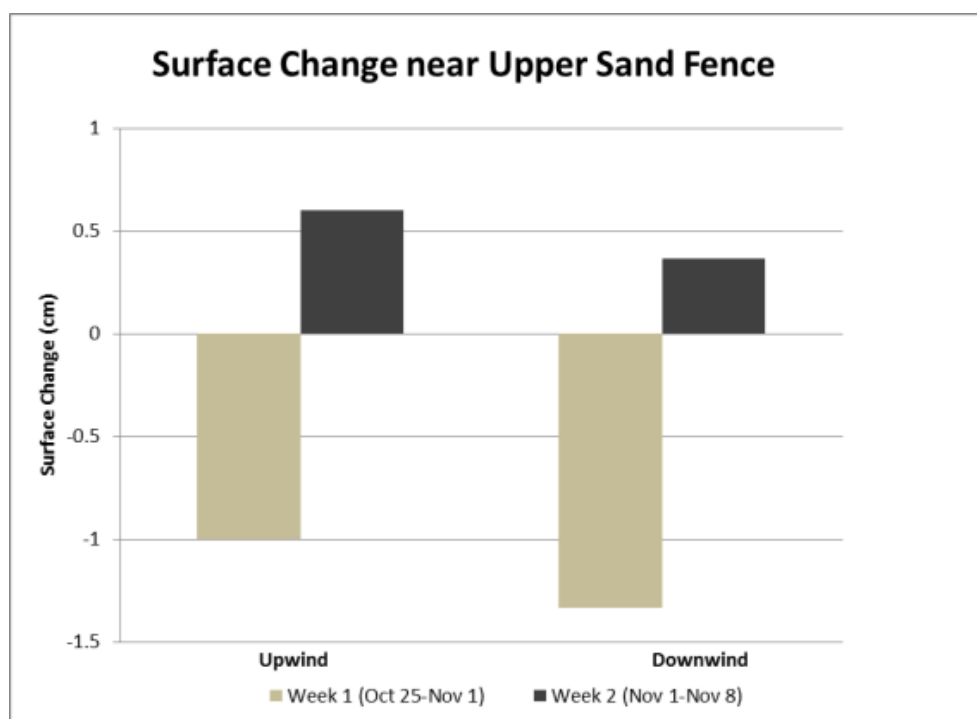
Figure 9: Weekly change in surface level for rows of erosion pins near the upper fence.

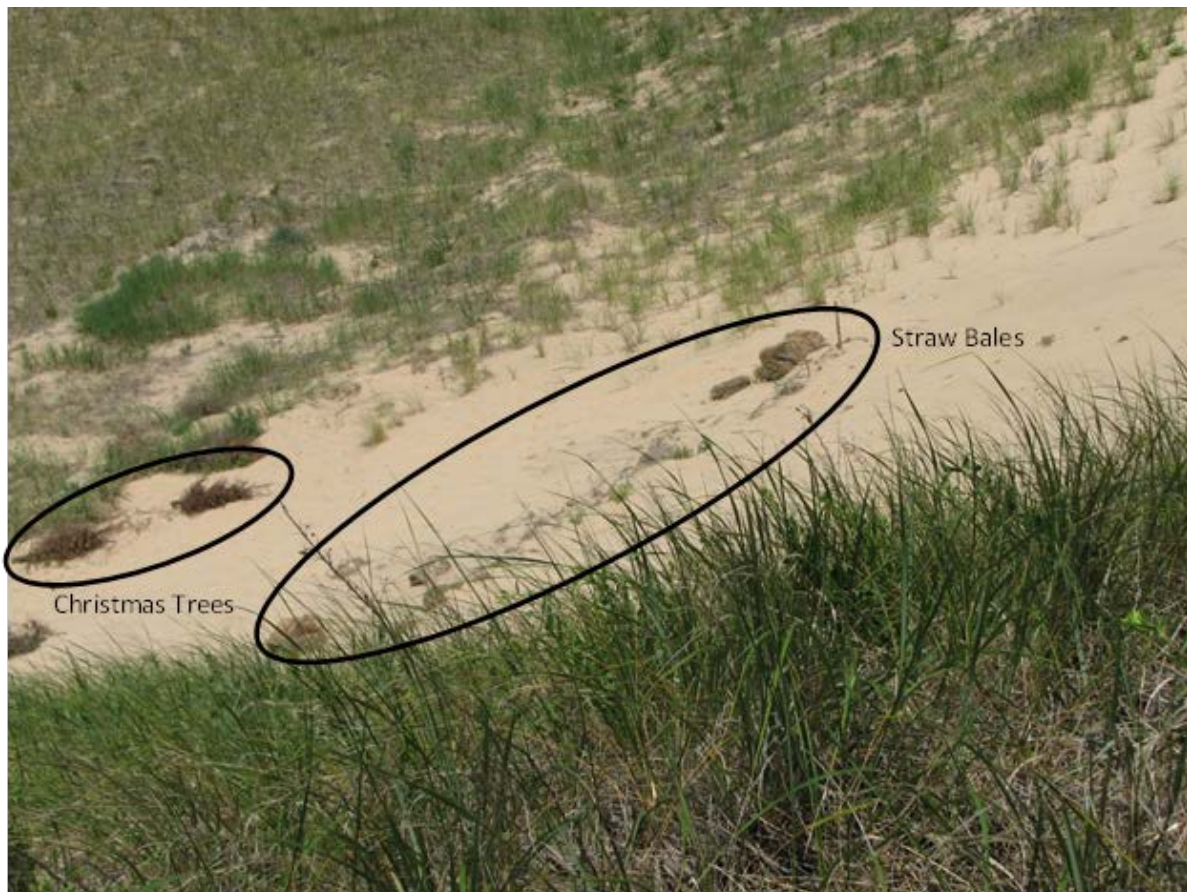
Figure 10: Deposited sand on the blowout face tended to slide downslope, unless it encountered solid objects like straw bales or Christmas trees embedded in the dune. Photo taken April 2012.

Several relevant observations on the dune were noted during the study period. Primarily, the dune surface was steep (average angle of 27°), which made deposited sand prone to mass wasting events. Sand that was deposited on the slope of the dune tended to slide down the dune face, unless the sand encountered a stable object embedded in the dune, such as a straw bale or Christmas tree (Figure 10). Furthermore, sand easily slid under the flexible plastic netting of the sand fences (Figure 11). Vegetation planted in April 2012 was still alive, yet not firmly rooted. Finally, the two sand fences, installed in April 2012, were already showing signs of deterioration. The ends of the fences were beginning to fall over and small rips were present in the fencing material itself (Figure 12).

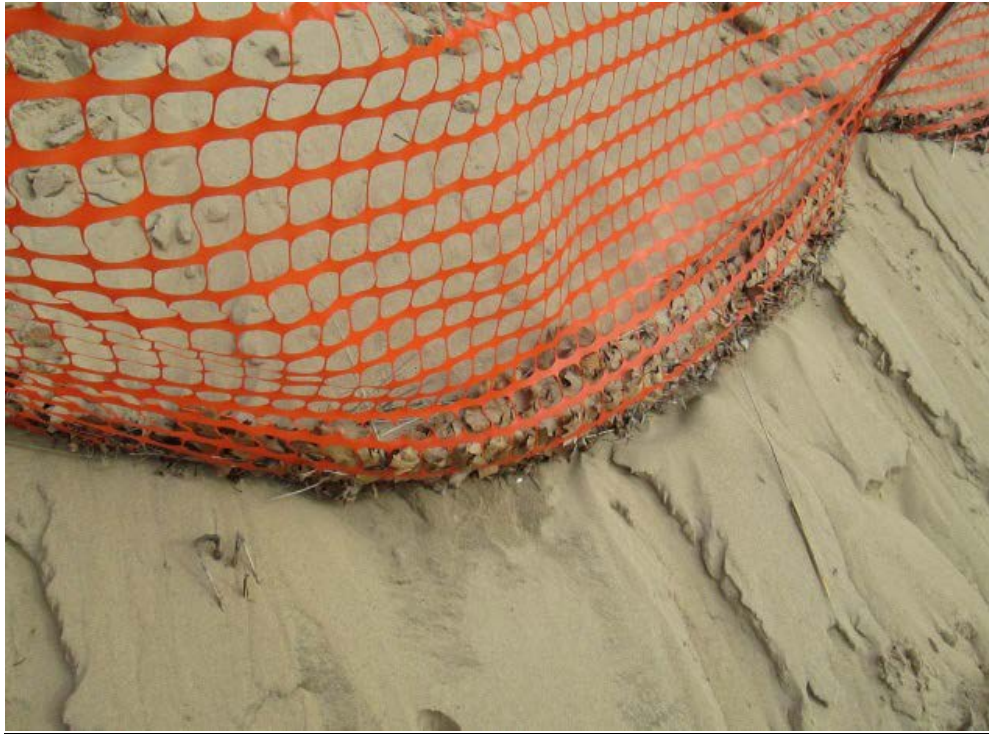
Figure 11: Deposited sand easily slid under the flexible plastic netting of the sand fences. Photo taken November 2012.

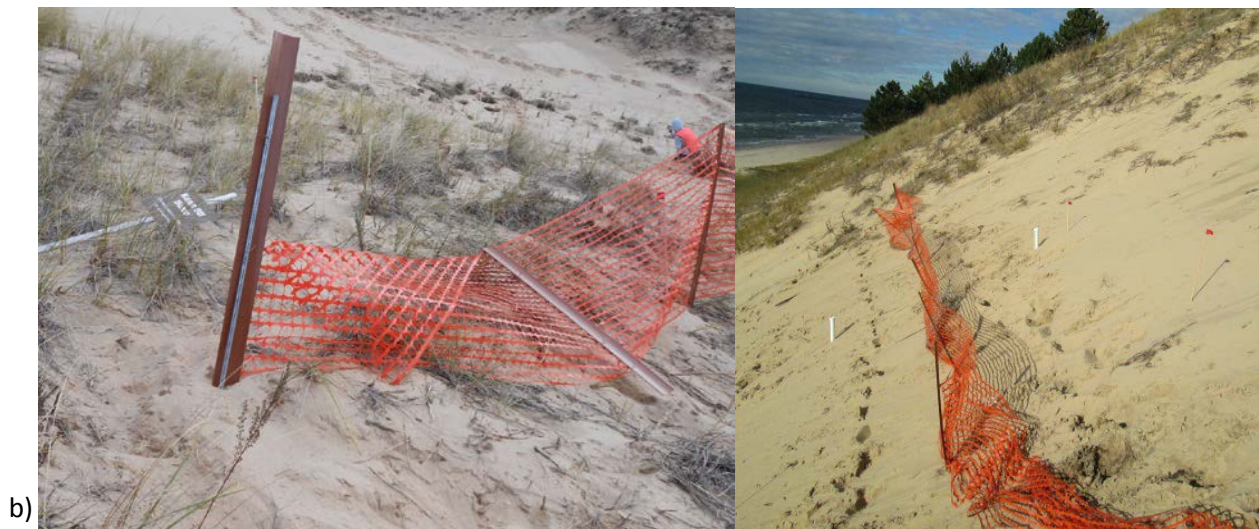
Figure 12: Although installed in April 2012, by November 2012 the sand fences already showed signs of deterioration. (a) lower sand fence (b) upper sand fence. Photos taken November 2012.

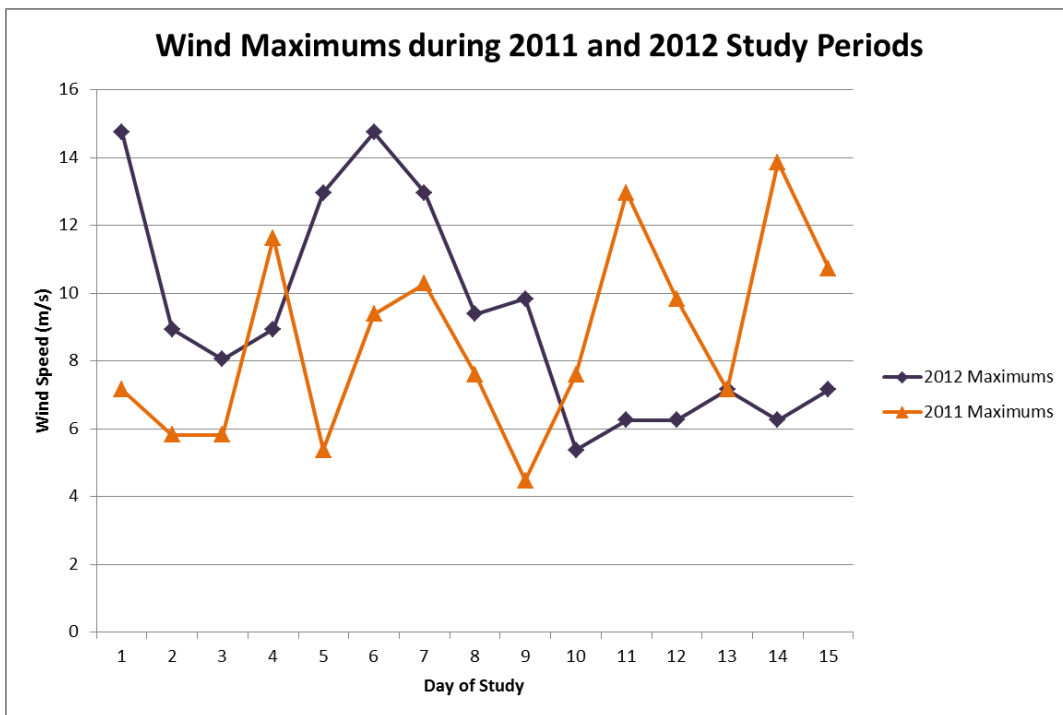
Figure 15: Comparison of daily maximum wind speeds for the 2011 and 2012 study periods. Data from the Muskegon, Michigan station (National Weather Service 2013).

Analysis of 2012 wind data revealed that Castle Park Dune experienced a major storm event when the remnants of Hurricane Sandy passed over the location (Figures 14 and 15). This storm had daily wind speeds averaging 6.5 m/s with a daily average maximum speed of 11.6 m/s (maximum 14.8 m/s) from October 25 to October 31; daily average wind speed over the remainder of the 2012 study was 3.1 m/s with daily average maximum wind speed of 7.2 m/s (maximum 9.8 m/s) (National Weather Service 2013).

Overall wind activity during the 2011 study was less than the 2012 study. Daily average wind speed was 4.0 m/s and daily average maximum wind speed was 8.6 m/s (maximum 13.8 m/s) from October 27 to November 10; however, there was a smaller storm event in 2011, with daily wind speeds averaging 5.1 m/s and daily average maximums of 10.9 m/s (maximum 13.8 m/s) from November 6 to November 10 (National Weather Service 2013).
