Evaluating Sand Fence Placement, Purpose, and Efficacy on West Michigan Dunes

**FYRES: Dunes Research Report # 20
June 2016**

Department of Geology, Geography and Environmental Studies
Calvin College
Grand Rapids, Michigan

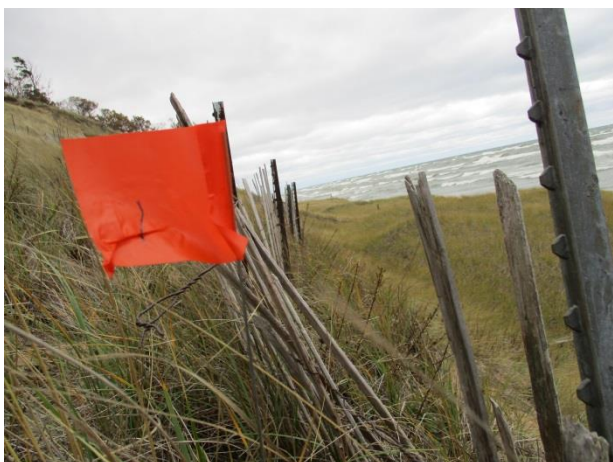
Figure 2: A numbered flag was placed near each fence in order to ensure consistency.

We assessed characteristics of wooden slat sand fences and their surrounding environment at each study site. Each observed fence was assigned a number and was marked with a flag (Figure 2). Documentation included mapping the fences, measuring fence height to calculate amount of deposition (Figure 3), measuring slope angle, estimating porosity, categorizing fence damage and deposition, qualitatively documenting surroundings and fence condition, and photo-documenting the fences and their settings (Table 1).

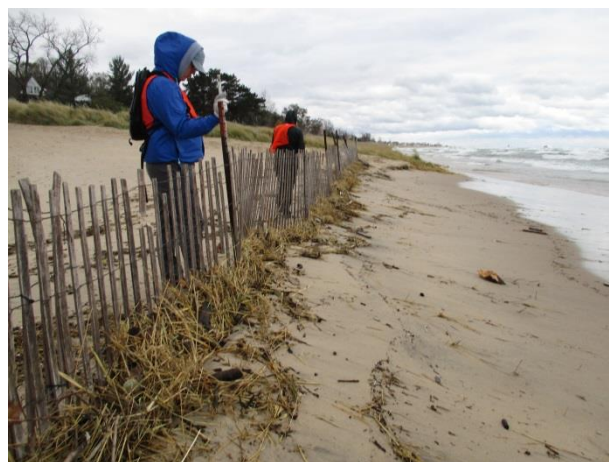
Figure 3: A team member uses a meter stick to measure the height of a fence above the sand.

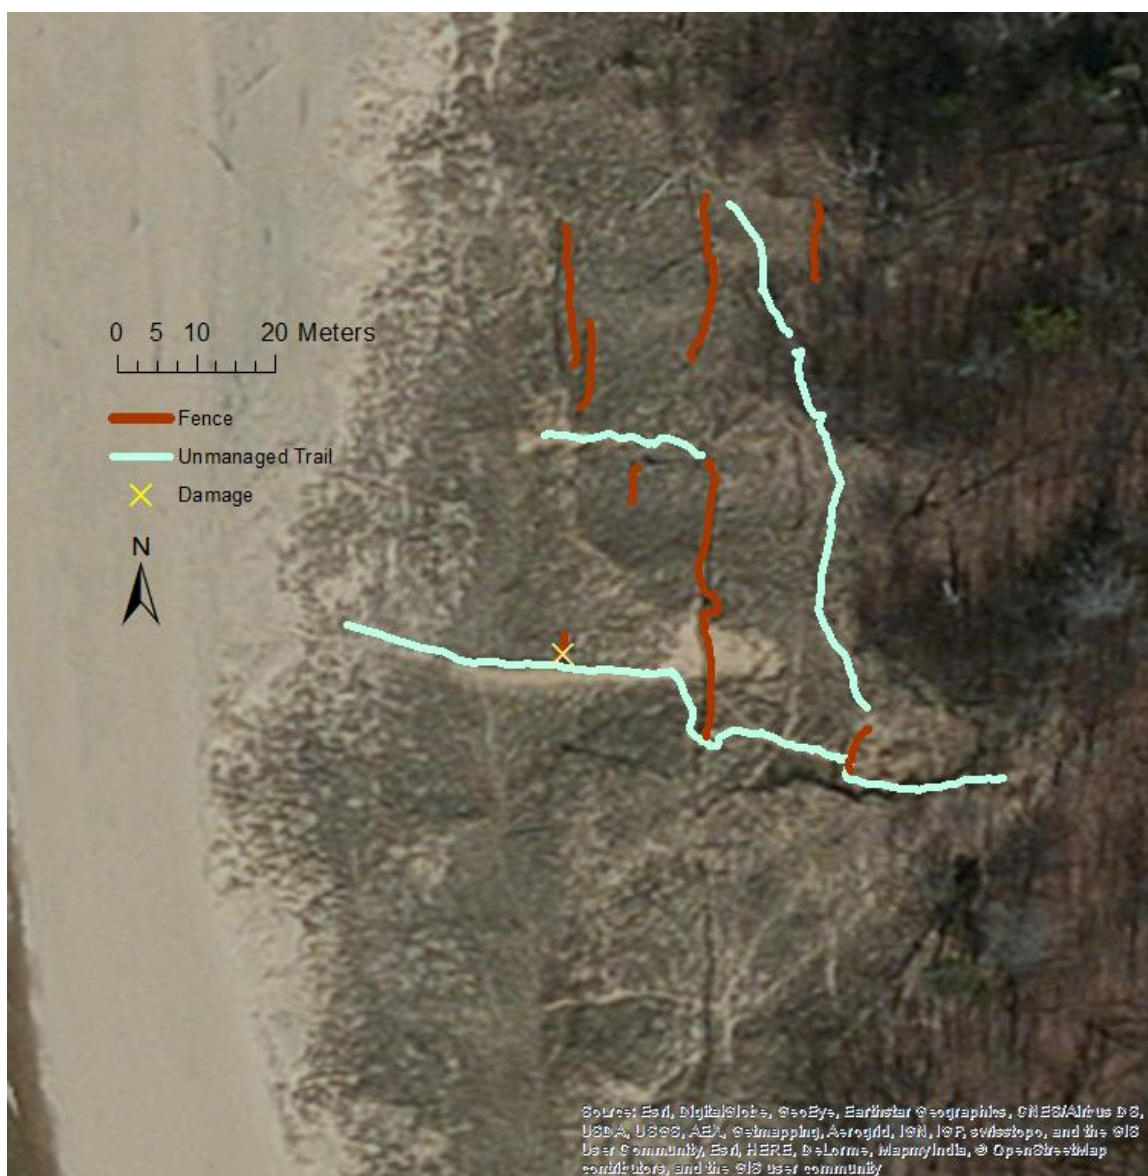
Figure 4a: Fences, unmanaged trails, and damage at Kirk Park.

At Kirk Park, the setting was mostly vegetated and close to the shore, with signs surrounding the area telling people to keep off the dune. The majority of Kirk Park's foredune was vegetated and 5 to 7 meters away from the shoreline. The majority of the fences we observed were surrounded by vegetation. The dune's elevation was high and contained boardwalks near the crest of the dune. Litter and unmanaged trails were visible on the dune.

At Kirk Park, a long unmanaged trail went around the southern edge of a row of fences. At Mt. Pisgah, one unmanaged trail extended from the boardwalk platform and through a break in a fence. Traffic also appeared to have caused some damage going through another intact fence. Another unmanaged trail was located just west of the edges of two fences. At the North

At Kirk Park the fences appeared to have been unsuccessful at keeping people off of the dunes, based on the amount of damage observed combined with the presence of unmanaged trails. At Mt. Pisgah the fences appeared to have successfully kept people off the dune. The signs showed that management was attempting to restore the large blowout on the dune, and the fences appeared to be contributing to stabilization.

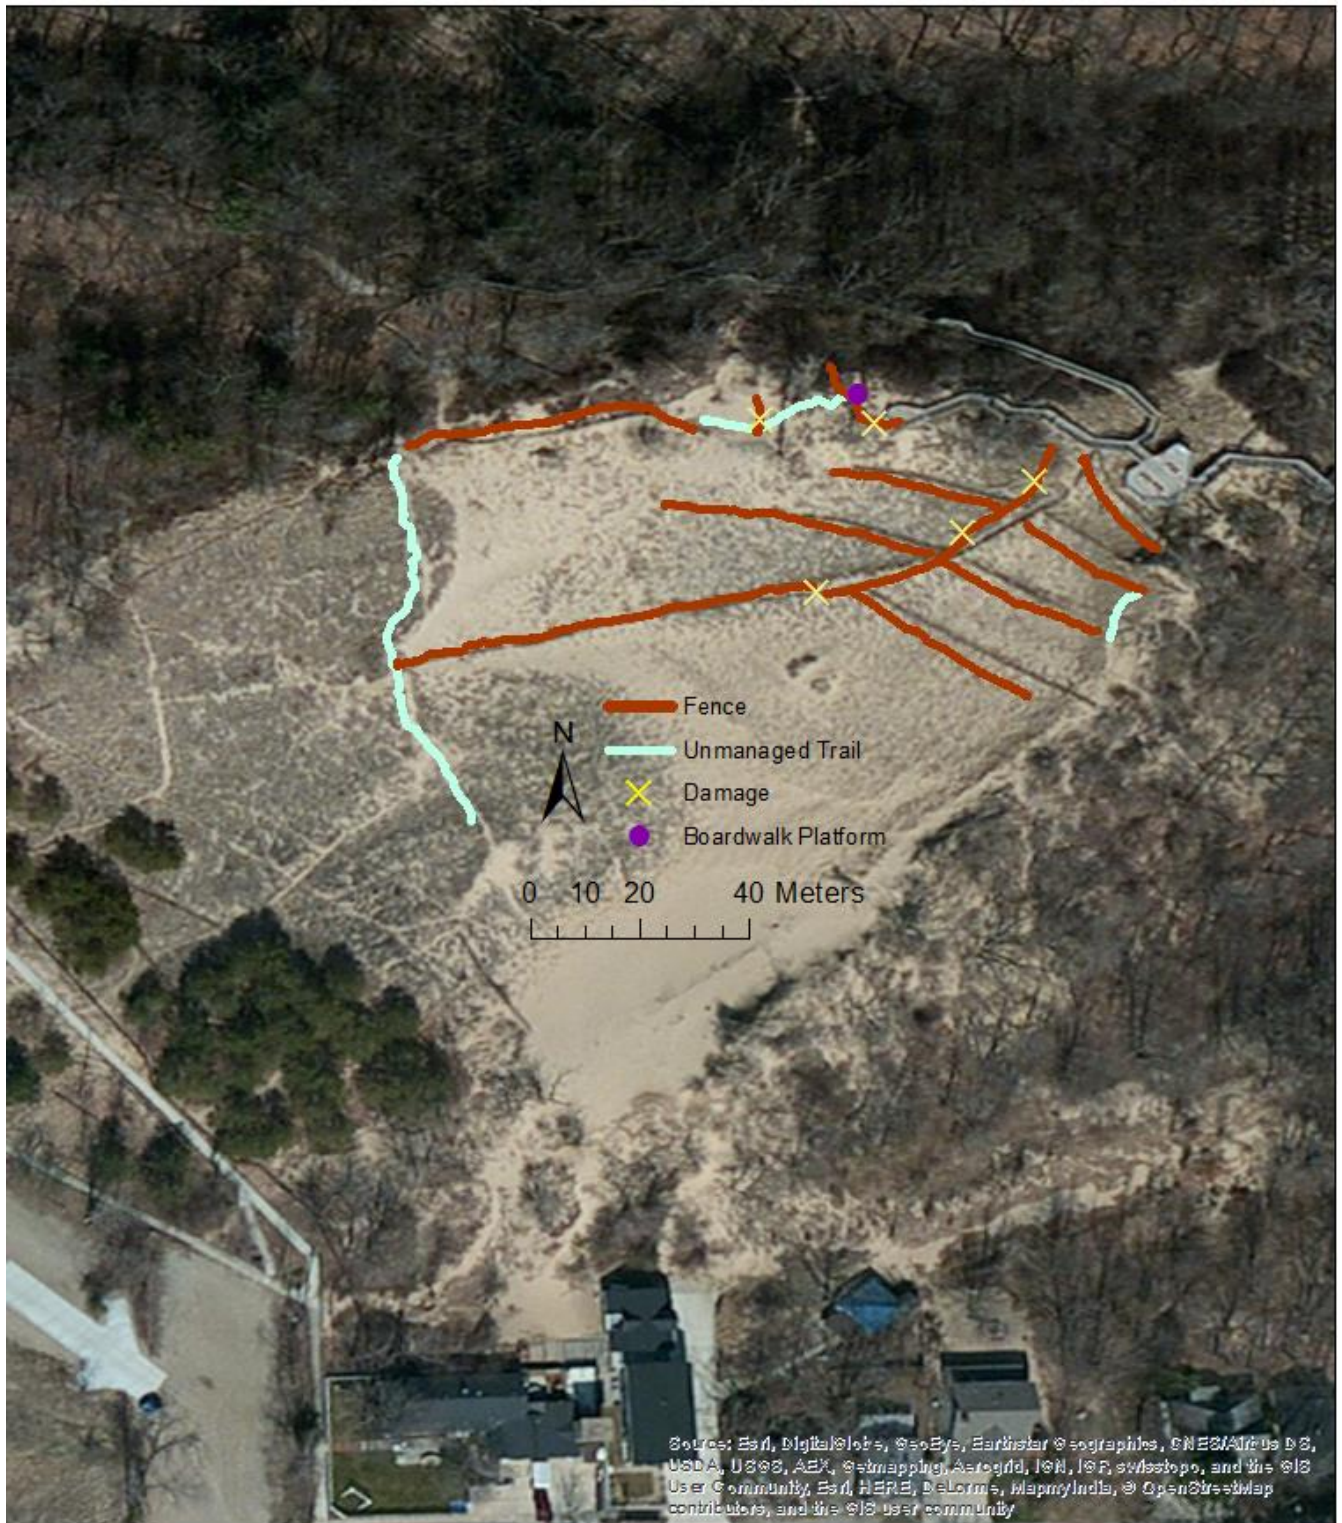
Figure 4c: Fences, unmanaged trails, damage, and boardwalk platform at Mt. Pisgah.

Mt. Pisgah was very high in elevation, providing stairs and boardwalks to walk on. There was a large blowout at the top of the dune and trees surrounded the leeward side of the dune where a boardwalk provided access to the crest. Mt. Pisgah was separated from the beach by houses and roads in a small neighborhood. All of the fences we documented were located within or along the edge of the blowout.

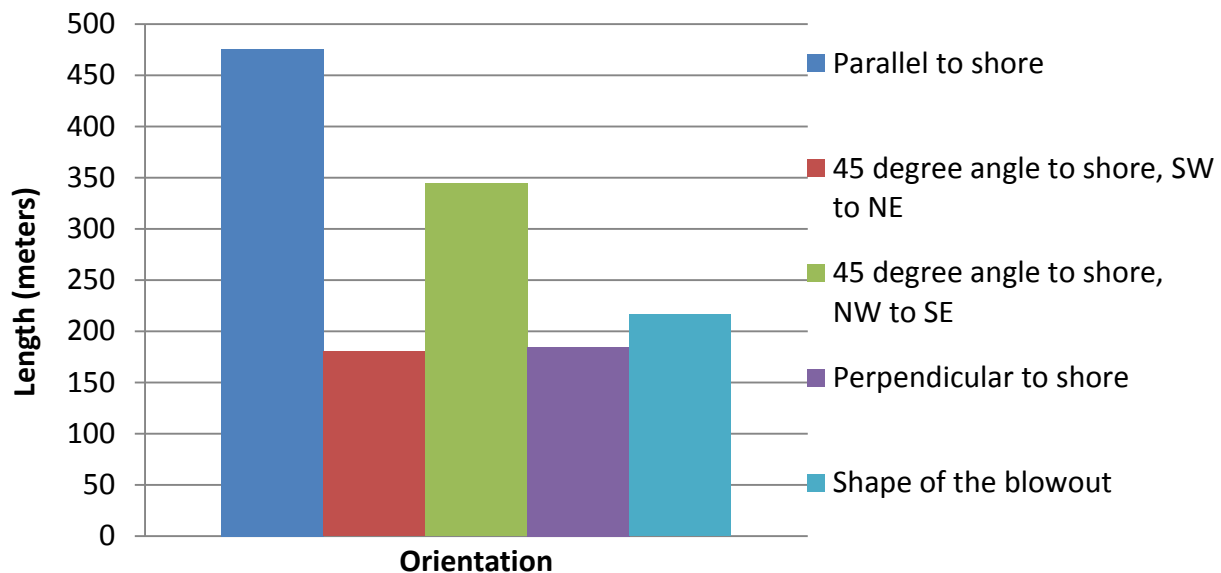
Fence orientation could fit into one of five categories: parallel to the shore, 45-degree angle to shore (either SW to NE or NW to SE), perpendicular to the shore, or assuming the shape of the blowout. Of all fences observed, more meters of fence were oriented parallel to the shore than in any other direction (Figure 5).

Figure 5: Length of fences observed for each orientation to the shore.

The variety of fence orientations that were not parallel to the shore may be affecting the dune environment in unnatural ways. Previous research suggests straight fences parallel to the shore encourage more natural dune morphology than do angled fences (Grafals-Soto and Nordstrom 2009). While our study observed the greatest number of fences were oriented parallel to the shore, the combination of all the fences from other orientation categories surpasses this number. Further research could focus on the effects of these fences in particular on the landscape. Additionally, a future study could document fences at additional dune sites to see whether sand fence trends observed by this study are representative of the Lake Michigan dunes as a whole.

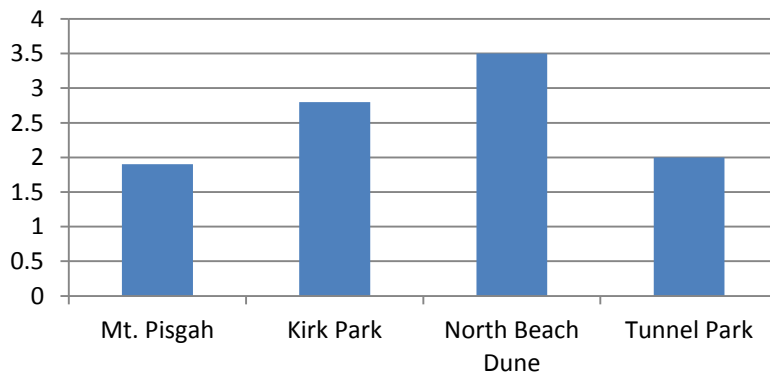
The greatest deposition on average was observed at the least vegetated site close to the shore in North Beach Park (Figure 7). At that site, a comparison of the sand deposition caused by the fences on the beach found considerable deposition near the shore, close to the fences thought to be more recently installed. These fences had an average deposition ranking of 3.5 out of 5. However, on the windward side of the dune, east of the parking lot, the fences appeared older and more damaged. The lowest average deposition ranking was observed at Mt. Pisgah, at 1.9 out of 5.

Figure 7: Average amount of deposition at each site (ranked on a scale of 1 to 5).

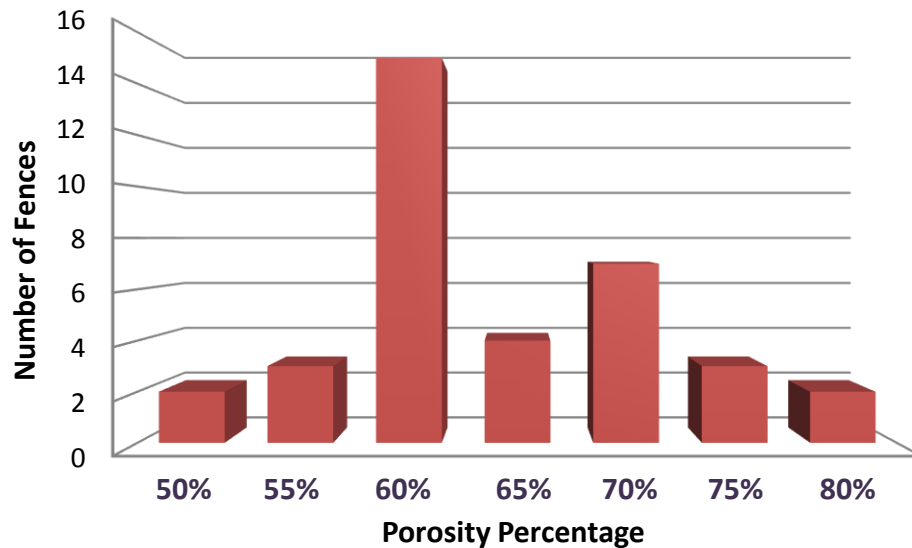
The porosity documented for the newest fences was 50%. The most frequent fence porosity observed was 60% (Figure 8), slightly more than that of a brand new fence. The most frequent reason for an increase in fence porosity appeared to be damage.

Figure 8: Estimates of sand fence porosity across all parks.

Damage to fences is likely reducing their effectiveness. As observed at North Beach Dune, the age of fences varied. Some appeared to have been installed fairly recently, while others appeared to be much older, with the older fences appearing to have withstood more damage and weathering over time. Most of the fences were damaged and could not trap as much sand as newly installed fences. Measured porosity was generally higher than the 30-60% porosity identified by previous research as ideal for the prevention of wind erosion (Dong *et al.* 2006; Tsukahara *et al.* 2012).

Collecting further information about the fences, such as their installation dates, could help to analyze the effects of weathering over time. Weathering was one of the forms of damage we observed; it visibly affected fence porosity, and ultimately the fences' ability to trap sand.

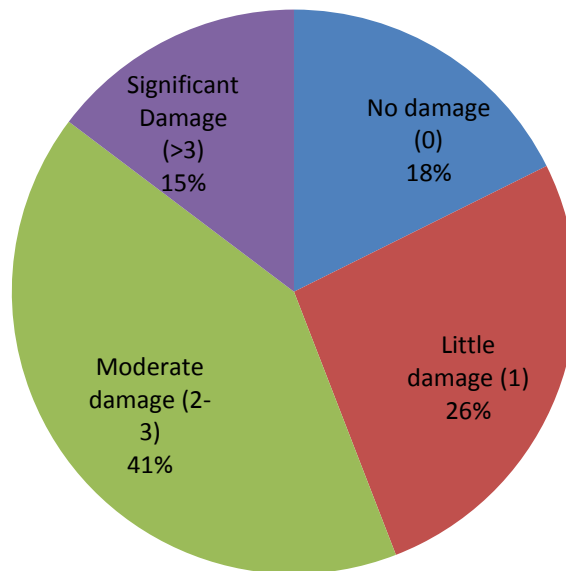
Most of the fences we observed were damaged in some way (Table 3). The most common causes were human traffic and weather conditions. The most common level of damage was “Moderate”, with 41% of fences observed demonstrating a level of damage ranked between 2 and 3 on a scale of 1 to 5 (Figure 9). The highest level of damage was observed at Kirk Park, with an average of 3.2 out of 5. The lowest level of damage was observed at the North Beach dune, with an average of 1 out of 5.

Figure 9: Amount of damage to each fence (ranked on a scale of 1 to 5).
