URGENT Medical Device Correction

M5071A (adult) and M5072A (infant/child) pads for use with HS1/OnSite/Home AEDs may experience gel separation and reduction of gel surface area

14-FEB-2022

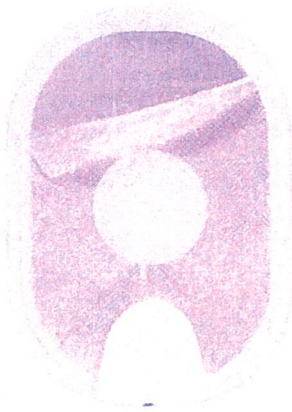
When a pad with separated, folded gel is placed on the patient's bare skin, the HS1/OnSite/Home AED could deliver less effective or ineffective therapy to the patient due to the reduced surface contact area with the skin. See example picture in **Figure 1**.

Figure 1: Separated gel that has folded onto itself when peeled.

Action:
Apply pads to the patient.
Do not hesitate.

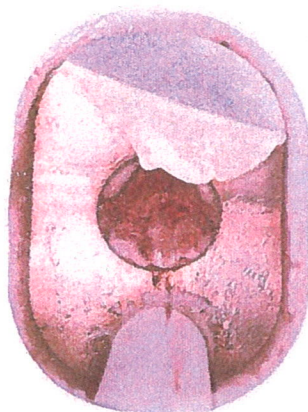
Separated, folded gel may also have a discolored and/or melted appearance. While the gel may also have a discolored and/or melted appearance, the appearance does not have any impact on the delivery of therapy;

however, there may be a delay in therapy if the user hesitates to apply the pad due to its appearance, and the AED may deliver less effective or ineffective therapy to the patient due to the reduced contact area with the skin. See example picture in **Figure 2**.

Figure 2: Separated, folded gel may also have a discolored and/or melted appearance.

Action:
Apply pads to the patient.
Do not hesitate.

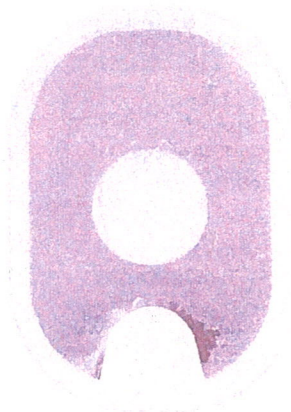
It is also possible that the gel could separate almost completely from the foam/tin backing when peeled, (see **Figure 3**.) Due to a small amount of gel surface contact area with the skin, electrical arcing could occur when a shock is delivered leading to burns to the patient’s skin, or the AED could be unable to deliver any shock through the pads. A delay in therapy will result while the user installs a replacement pads cartridge (if available) or performs CPR while waiting for Emergency Medical Services Personnel to arrive. For comparison, **Figure 4** shows a normal pad. No matter the state of the pad, follow the voice prompts because the AED will step you through the necessary actions.

Figure 3: Gel almost completely separated from backing.

Action:
Replace pads cartridge if a spare is available. If no spare is available, perform CPR until help arrives.

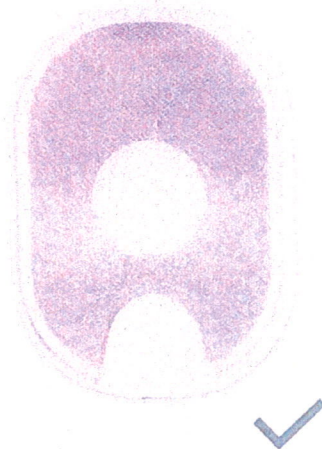
Figure 4: Normal pad.

Action:
Apply pads to the patient according to the Instructions for Use/Owner’s Manual.
